SNETTISHAM

HYDROELECTRIC

SECOND STAGE DEVELOPMENT

FINAL FOUNDATION REPORT

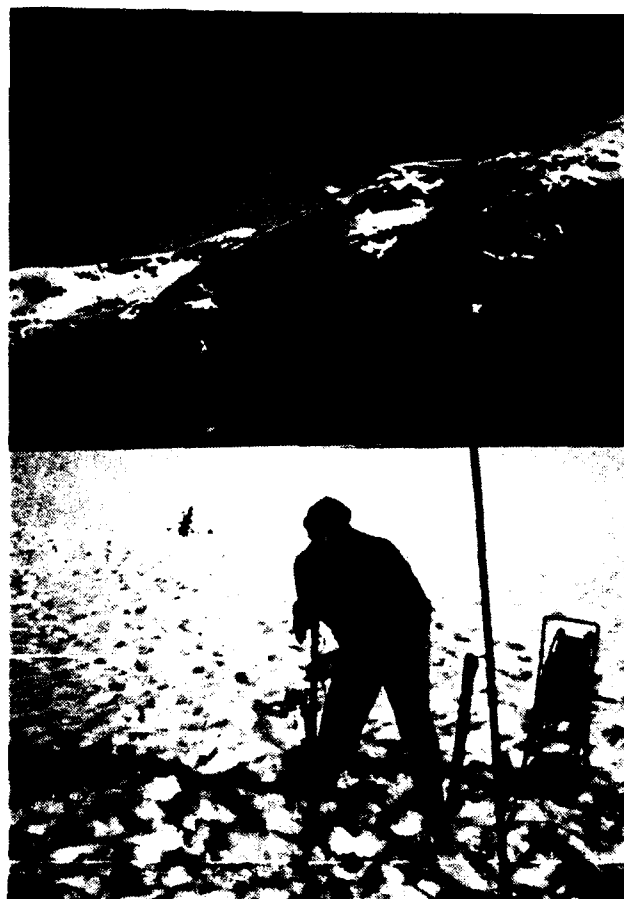
Photo 16: Sounding the bottom of the lake through the ice prior to the underwater lake tap

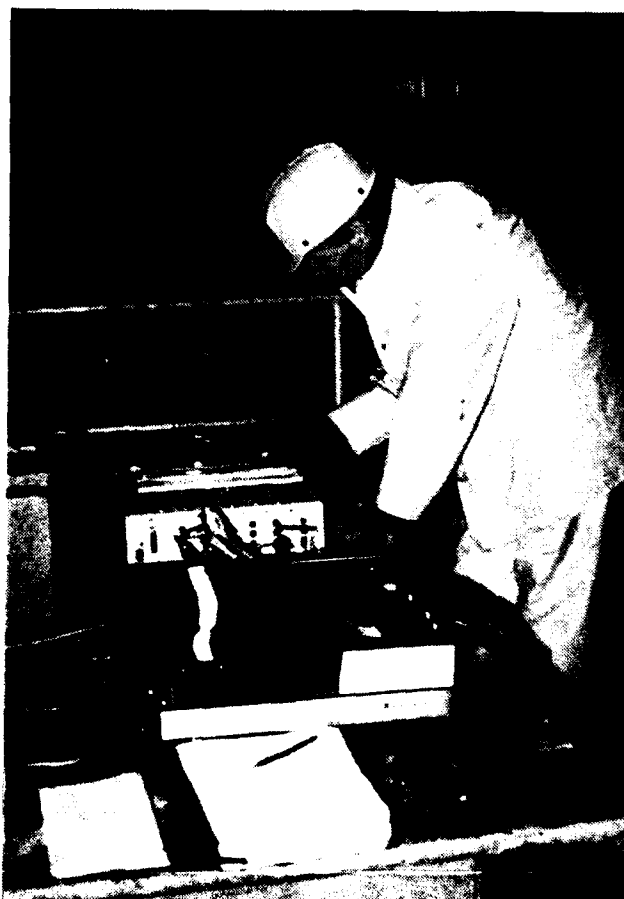
Photo 20: Instrument recorders of piezometers monitoring water pressures in lake tap and power tunnel area

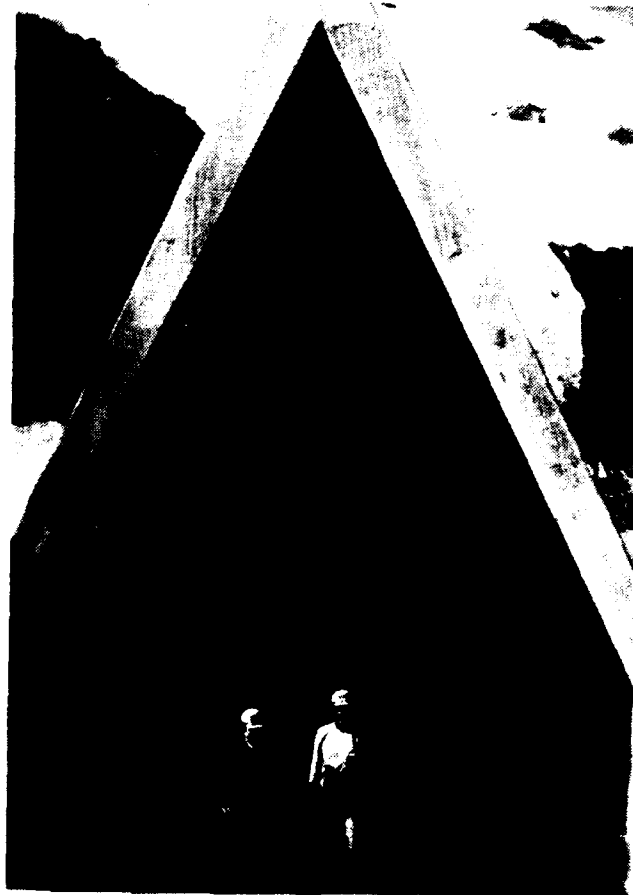
Photo 22: Crater Lake access tunnel with avalanche shed portal structure
